BELVEDERE CLUB 2019 ARCHITECTURAL INVENTORY

Site: 21 **Historic Name** N/A

Year Built c. 1900

Architectural Style Prairie style

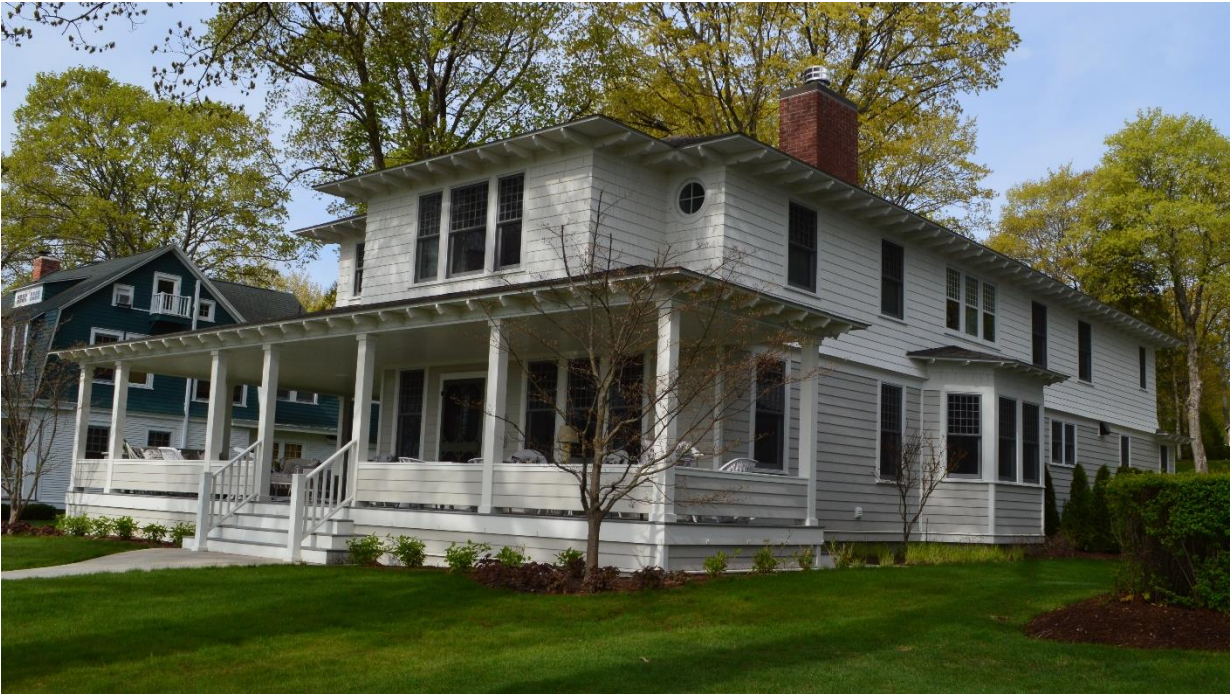
The two-story cottage has wide clapboard siding at the first floor and shingle siding at the second floor, a common treatment in the Prairie style. Originally the first floor had narrow clapboard siding. The porch has been reconstructed, eliminating the solid shingle sided knee walls and wide Doric pillars and increasing the slope so it intersects higher on the wall. The window opening locations at the second floor at the south side have also been altered. The two-story porch on the south side has been enclosed at the first floor and altered. The windows have been replaced but replicate the original multi-pane upper sash.

The cottage is in good repair no issues are apparent.
