BELVEDERE CLUB 2019 ARCHITECTURAL INVENTORY

Site: 29

Year Built c. 1890

Architectural Style Folk Victorian

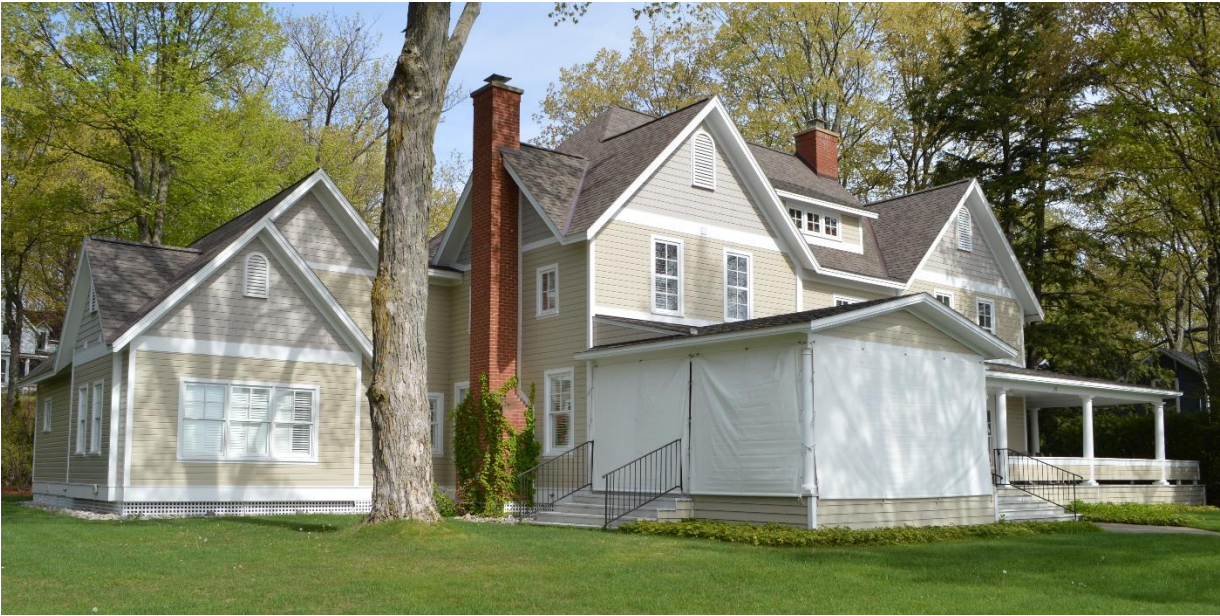
The two-and-half story cottage has clapboard siding with shingle siding in the gable fronts. The matching gable fronts connected by a side gable massing is indicative of the Folk Victorian style. The cottage has received a new foundation and the roof has been raised to create a taller attic. The shed roof dormer in the center of the front roof is new, as is the south side gable and addition. The arched vents in the gable fronts are new.

The cottage is in good repair no issues are apparent.
