BELVEDERE CLUB 2019 ARCHITECTURAL INVENTORY

Site: 49 **Historic Name** N/A

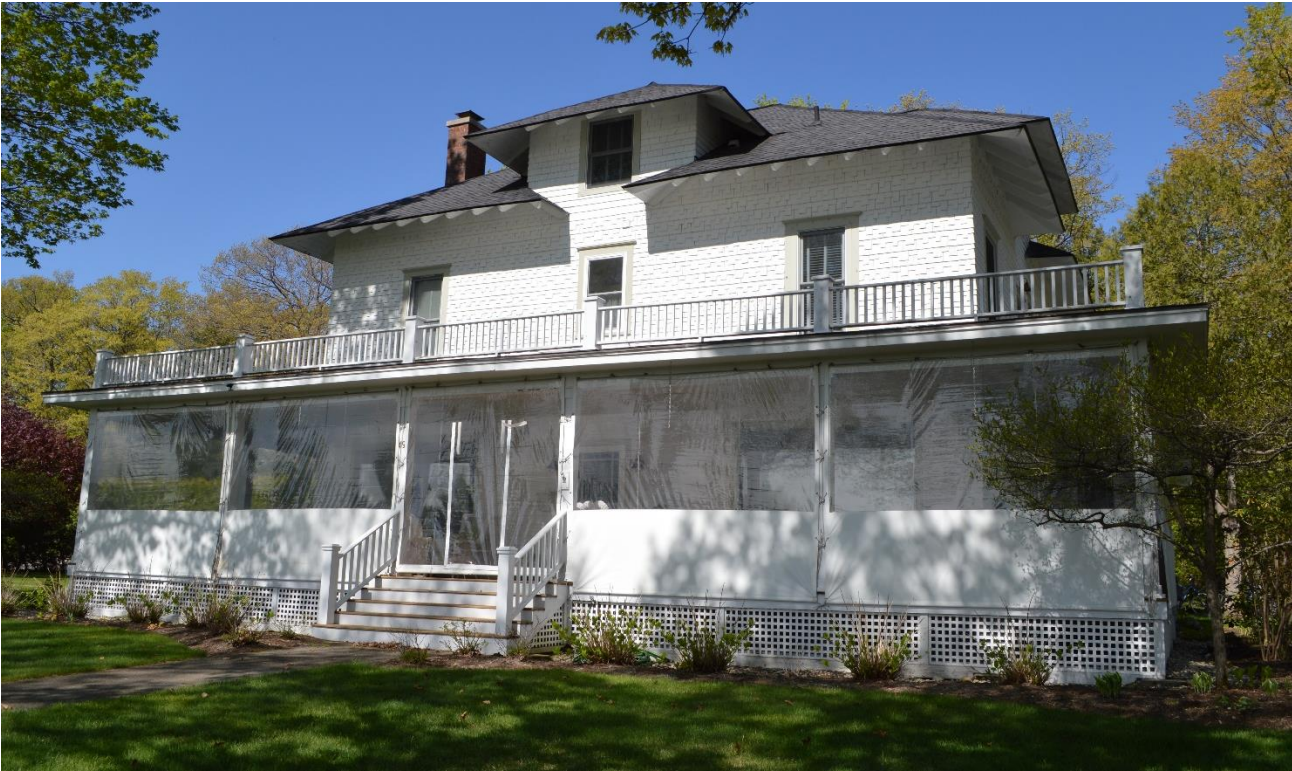
The two-story square massing, shallow hip roof with exposed rafter tails are all indicative of the Prairie style. The original front porch had shingle sided piers supporting shallow arches at the first floor. These have been replaced with Doric pillars. The wide clapboard at the first floor and shingle siding at the second floor do not appear to be original.

The cottage is generally in good repair with no apparent issues.
