BELVEDERE CLUB 2019 ARCHITECTURAL INVENTORY

Site: 209

Year Built c. 1900

Architectural Style Shingle

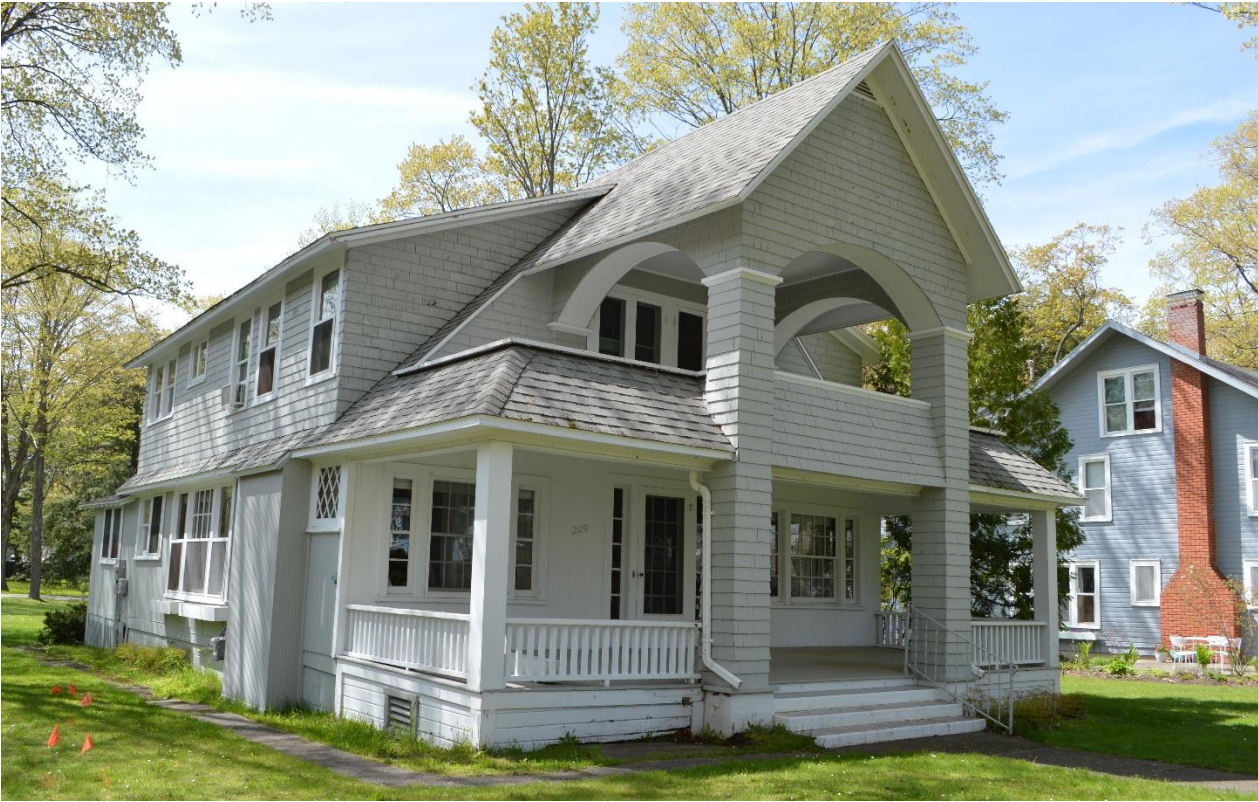
This one-and-a-half story cottage has narrow vertical siding at the first floor and shingles at the second. Without historic photos it is difficult to tell whether the shingled pillars supporting the large gable front creating a deep second floor porch is original. The large brick chimney on the south wall has been removed to the first floor and roofed over.

The cottage appears to be in good repair with no apparent issues although the large shrubbery that touches the sides could cause moisture damage in the future. Moss is growing on portions of the roof.
