BELVEDERE CLUB 2019 ARCHITECTURAL INVENTORY

Site: 402 **Historic Name** N/A
Year Built c. 1890
Architectural Style Queen Anne

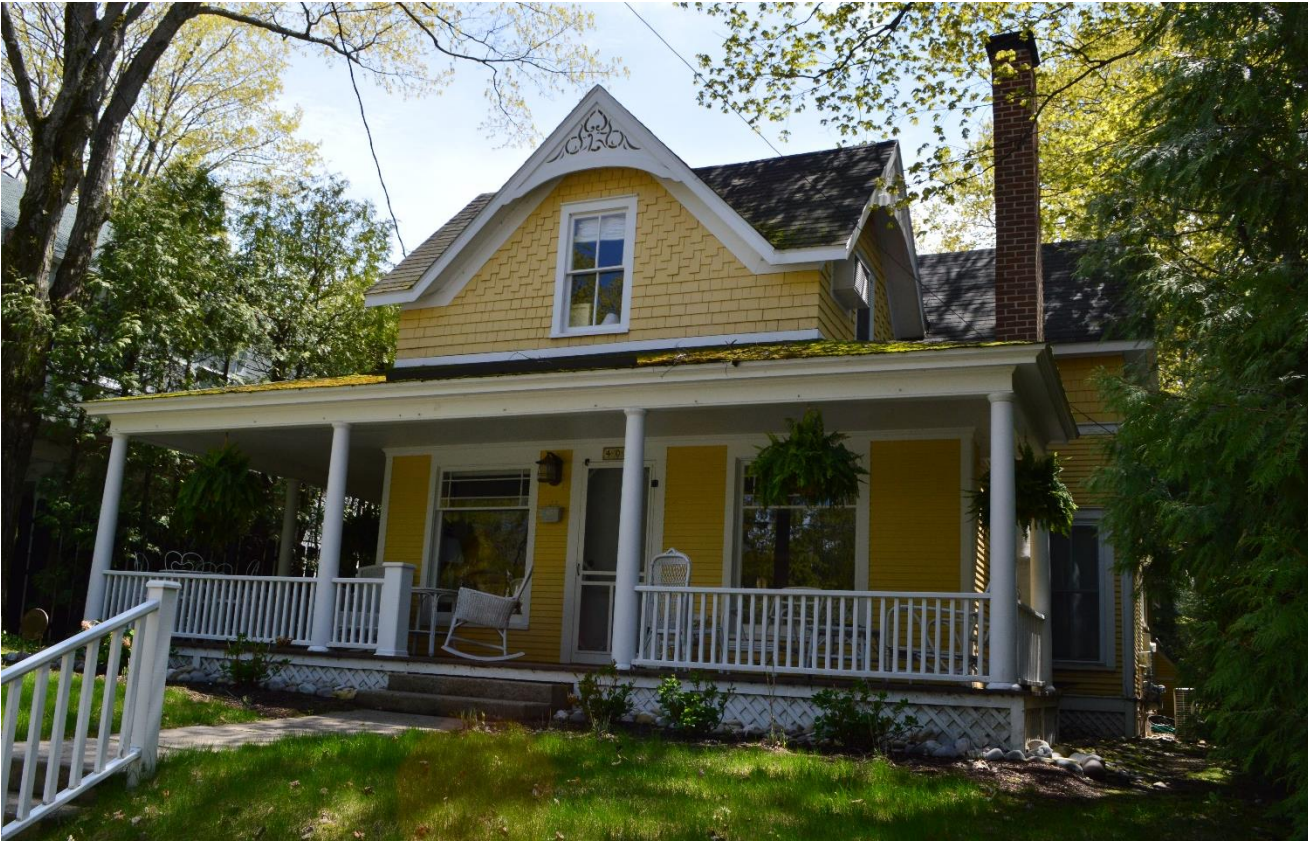
The cottage appears to be in good repair, the moss growing on roof surfaces could cause premature deterioration of the shingles.
