BELVEDERE CLUB 2019 ARCHITECTURAL INVENTORY

Site: 3

Architectural Style Craftsman

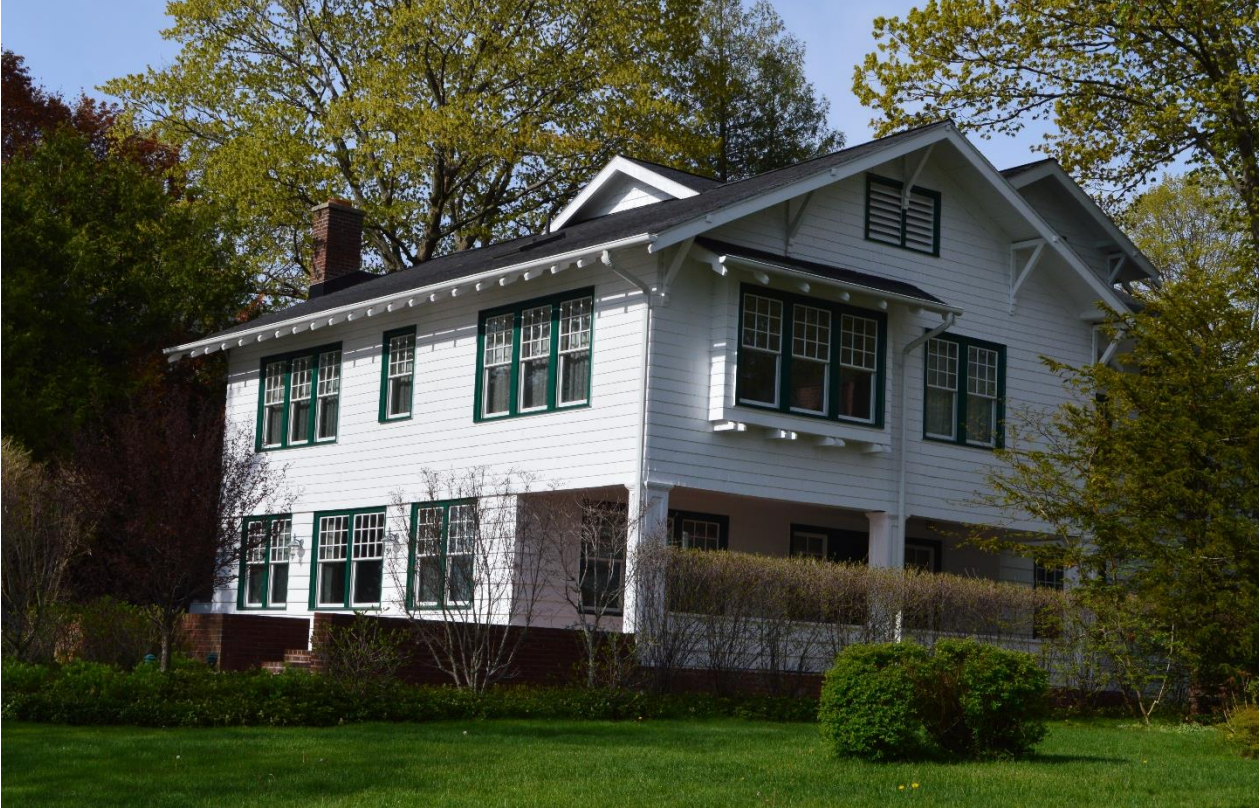
The two-story tall side gable with the side-facing porch recessed under the second floor which creates an unusual massing for the Craftsman style. The exposed rafter tails, triangular brackets in the gable, and the projecting bay at the second floor of the north elevation are characteristic of the Craftsman Style, as are the heavy porch pillars and shingle siding. Based on a historic photo this is not the original cottage on this lot.

- The asymmetrical façade with the porch recessed under the second floor, the square porch columns have recessed panels and are in the Doric style. The massing is somewhat unusual for the Craftsman style.
- The shingle siding, projecting second floor bay with shed roof, exposed rafter tails and paired brackets, along with the exposed rafter tails and triangular wood brackets in the main roof eaves are Craftsman style elements.
- Although the windows do not appear to be original they appear to replicate the original window configuration.

The cottage is in good repair with no obvious condition issues.
