BELVEDERE CLUB 2019 ARCHITECTURAL INVENTORY

Site: 5

Year Built 1913, Fred H. Thomas, architect

Architectural Style Prairie

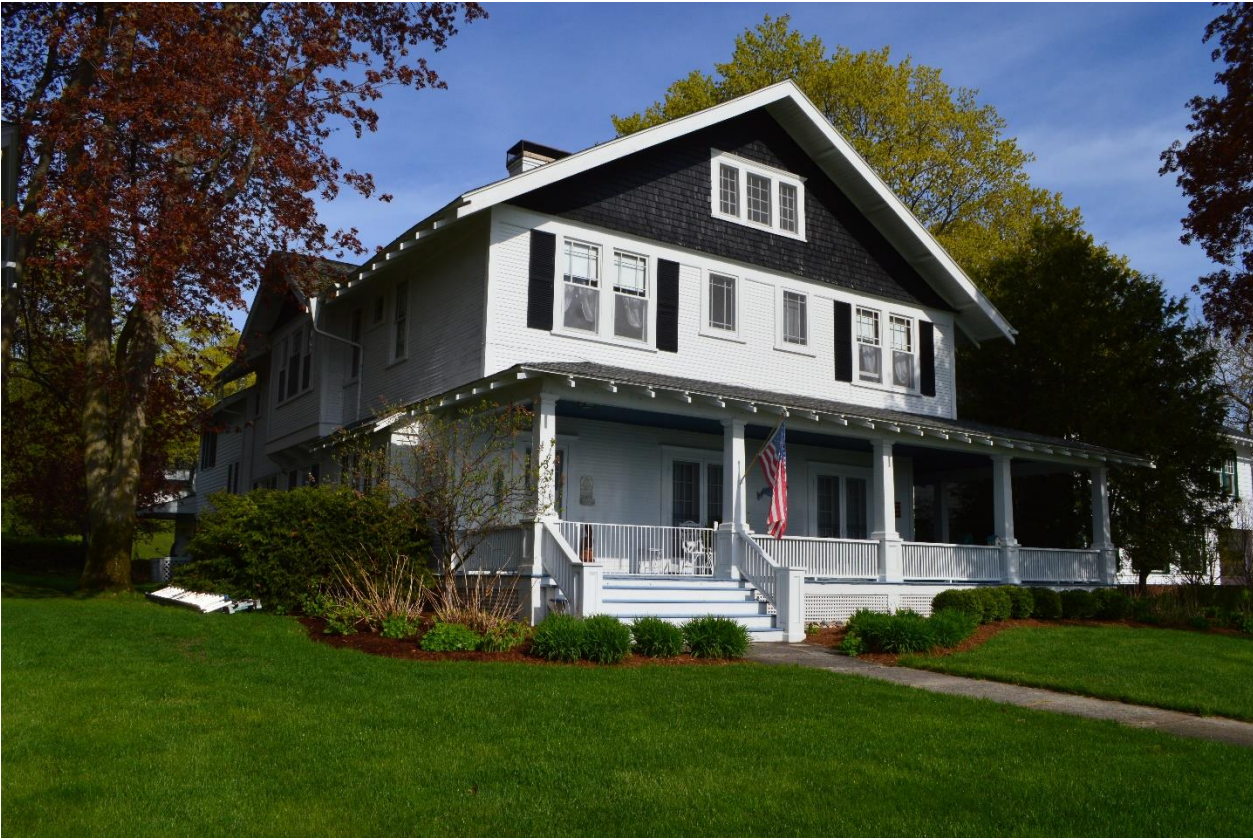
Two-and-a-half story gable front with hipped roof front porch. The main and porch roofs have exposed rafter tails. The first two floors are clad in narrow clapboard siding and the gables are clad in wood shingles. The two types of original windows remain, the double-hung with the patterned muntins in the upper sash, as well as the multi-pane casement windows. The front porch is supported by heavy tapered wood piers with a base are indicative of the Prairie style. The wide front porch and large windows on the front façade take advantage of the lake views.

- Gable front with cross gables toward the rear. The façade is symmetrical and features a full width front porch with a hipped roof supported by wood pillars. The simple wood railing between the pillars appears to be original.
- The narrow profile clapboard siding at the first two floors and shingle siding in the gables.
- The projecting bays, including the supporting brackets and exposed rafter tails.
- The wood windows with the patterned muntins and multiple panes, including the surrounding wood trim.

The cottage is in good repair with no obvious condition issues. The original cottage appears to retain most of its original materials and features. The shutters are not original.
