## BELVEDERE CLUB 2019 ARCHITECTURAL INVENTORY

**Site:** 11

**Historic Name** Exedra

**Year Built** 1892

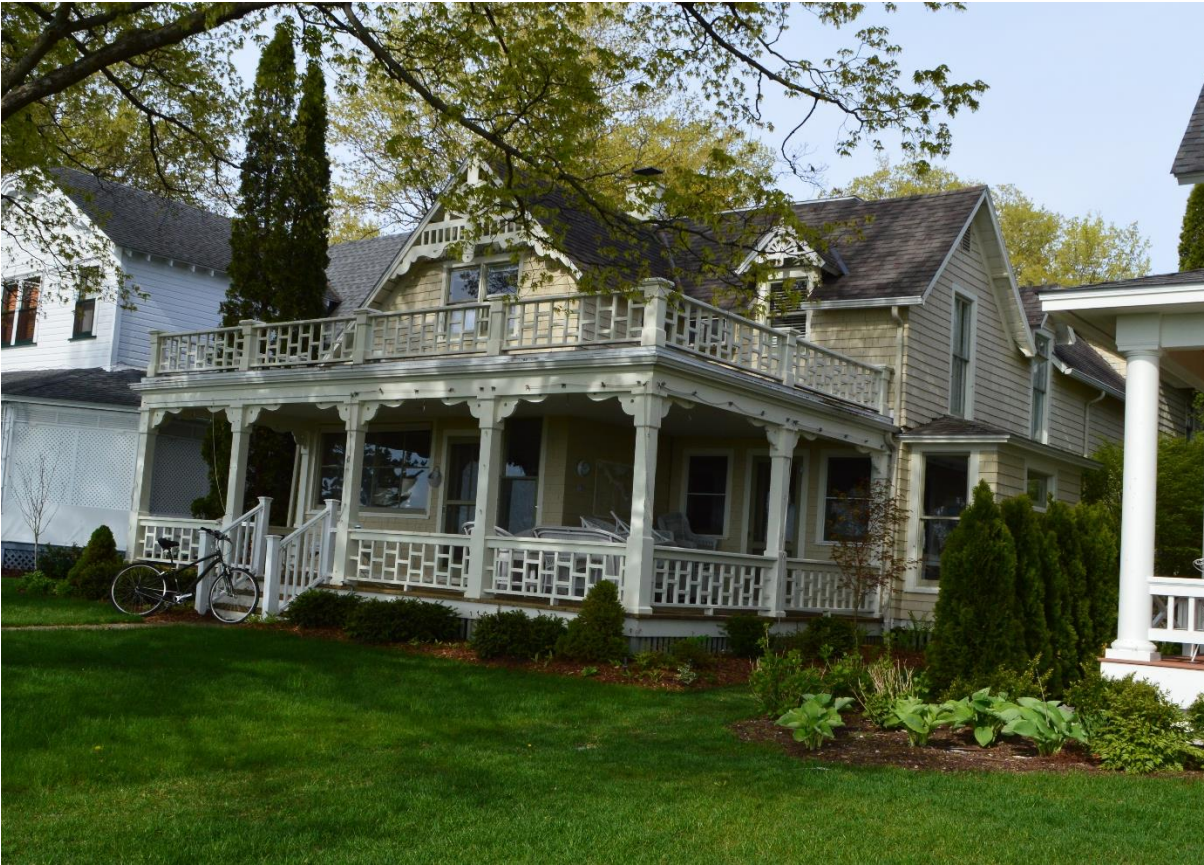
The full front, two story porch and gable front are indicative of the Queen Anne style. In comparing the existing house with the 1904 photo it appears that the gable decoration, porch posts and railings do not match the original. These features could have been added historically. The window openings on the second floor have been shortened.

- Decoration/vergeboards in the gable front and in the gable front dormers, it does not exactly match the original but could have been added historically.
- Shingle siding, some window trim
- Possibly the decorative treatment on the porch posts and fascia, this does not appear to be original but may have been added historically.

The cottage is in good repair no issues are apparent.
