BELVEDERE CLUB 2019 ARCHITECTURAL INVENTORY

Site: 19

Historic Name Sans Souci

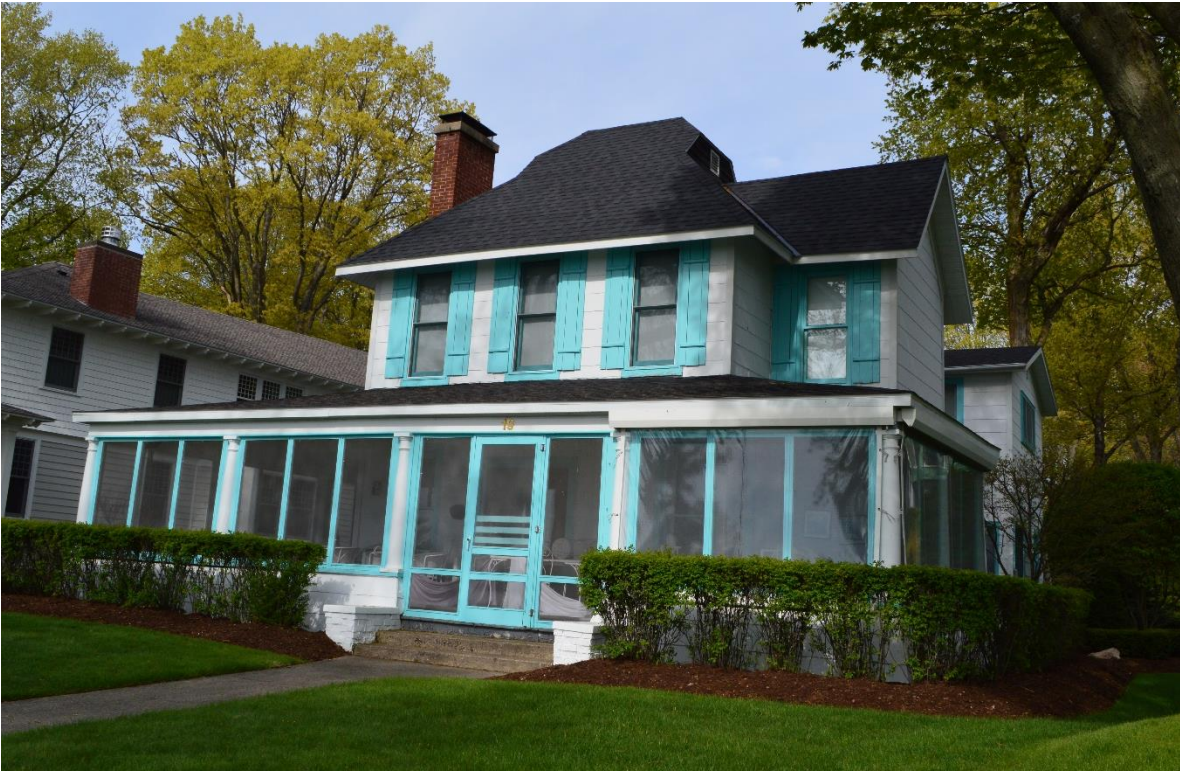
Although the east portion of the footprint of the two-story cottage is similar to the original, the alteration of the front porch and main roofline have eliminated the original Queen Anne detailing. A decorated gable was eliminated from the main roof line. The porch was enlarged and what appears to have been turned posts have been changed to Doric columns. This change probably happened historically as it was a common treatment to Queen Anne houses.

- Clapboard siding.
- Doric porch columns.
- Shape of the roof line near the peak which is original.
- Second floor window openings, the locations appear to be original.

The cottage is in good repair no issues are apparent.
