BELVEDERE CLUB 2019 ARCHITECTURAL INVENTORY

Site: 33

Architectural Style Shingle Style

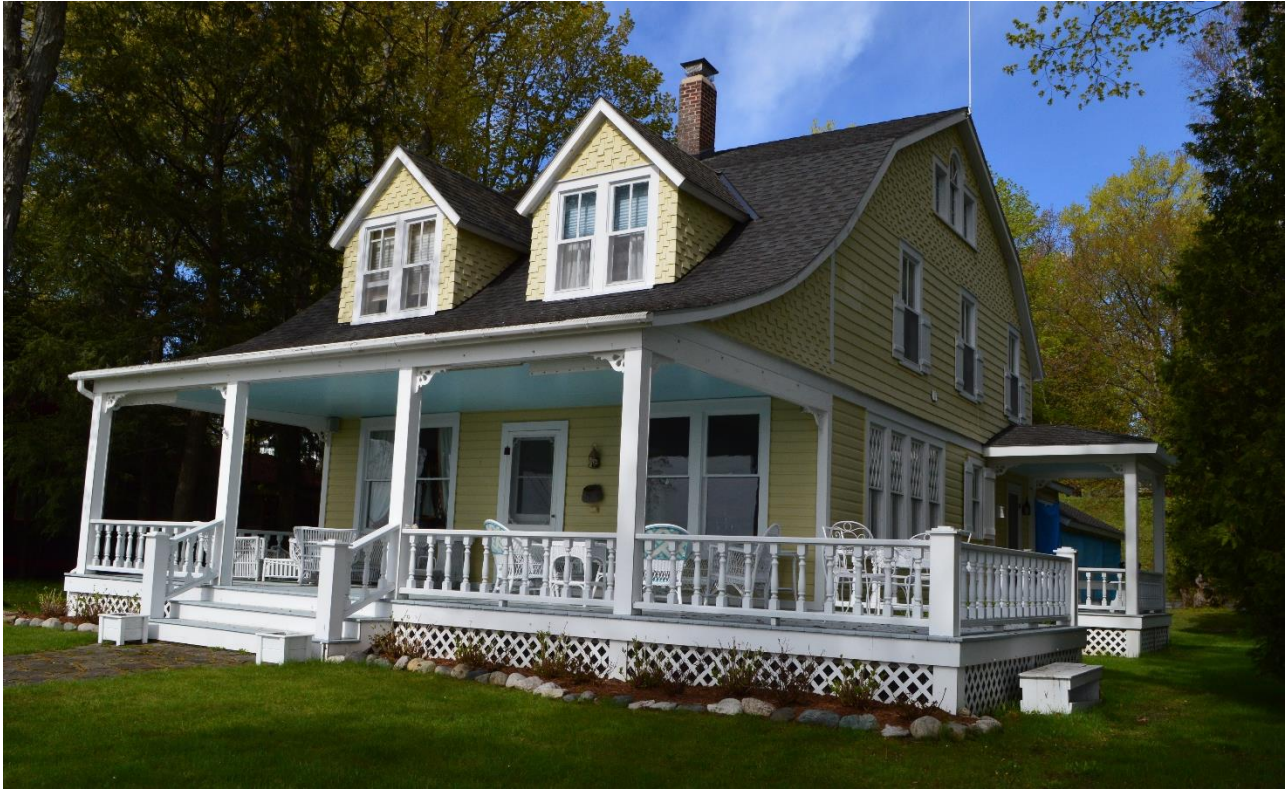
The roof line of this two-story cottage was altered from a steep curved gable to more like a gambrel roof near the top. It appears the Palladian type window in the gable ends was added at that time. The curve at the bottom which creates the front porch roof was retained, an important characteristic of the Shingle style. The windows with the diamond panes in the upper sash and two panes in the lower sash on the north side appear to be original, as does the porch that extends to the north.

- Narrow clapboard siding at first floor with shingle siding on upper floor.
- Gable roof with curve at the bottom creating the front porch roof.
- Full width front porch with carved brackets at the posts and the north extension and railing.
- Diamond pane windows, including the windows with diamond pane in the upper sash and two panes in the lower sash.
- Palladian window in gable ends.
- Gable front dormers.

The cottage is in good repair no issues are apparent.
