BELVEDERE CLUB 2019 ARCHITECTURAL INVENTORY

Site: 35

Historic Name Hino-de-so

Year Built c. 1901

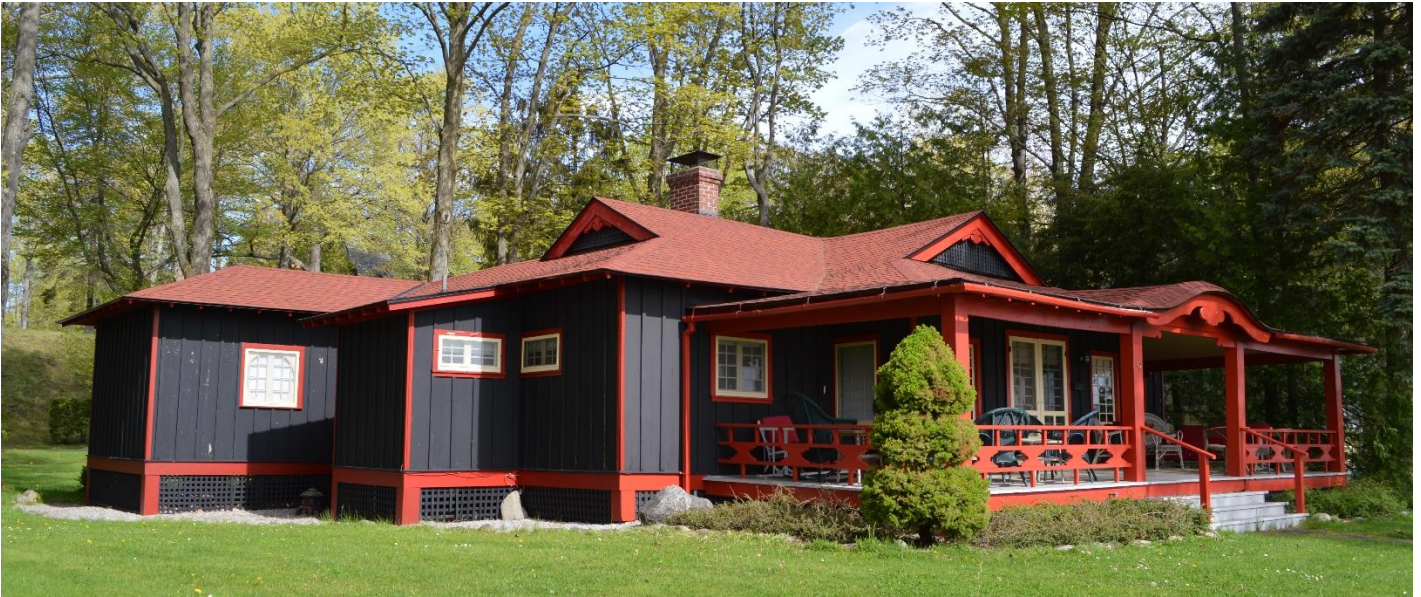
The shallow hip roof with exposed rafter tails along with the horizontal massing of this one-story cottage are indicative of the Prairie style. The carved decoration on the front porch and in the gable ends of the roof, along with the vertical board and batten siding show the Asian influences on the design. The multi-pane windows appear to be original.

- Shallow pitch hip roof and horizontal one-story massing.
- Carved decoration on front porch and in roof gables.
- Multi-pane windows.
- Curved roof in front porch over front steps.

The cottage is in good repair no issues are apparent. The cottage appears to retain most of its original features.

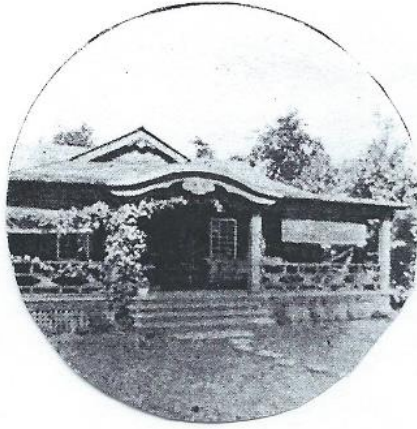
Chas. Gardner, Toledo, Ohio.
1907
