BELVEDERE CLUB 2019 ARCHITECTURAL INVENTORY

Site: 105

Year Built c. 1900

Architectural Style Shingle style

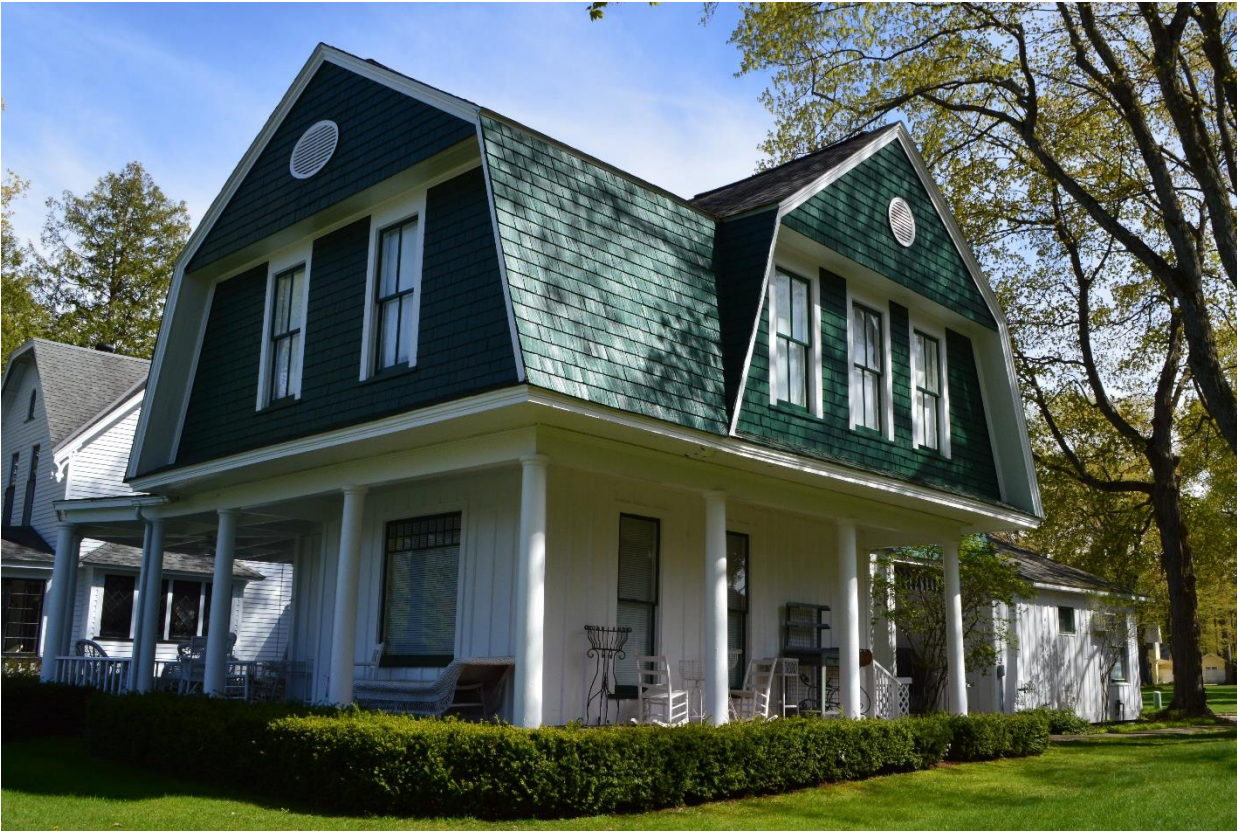
The gambrel front roof with cross gables clad in shingles that overhang the first floor creating a wrap-around porch supported by Doric columns are indicative of the Shingle style. The first floor is clad in board and batten siding and large front window with small panes at the top, as well as the two-over-two windows at the second floor are typical of the era.

- Gambrel roof with steep sides creating a second floor and cross gambrels that overhang the first floor creating a wrap-around porch with Doric columns.
- Multi-sided porch at the northeast corner.
- Vertical board and batten siding clad first floor, shingle clad second floor.
- Front window with small panes at the top, two-over-two windows at the second floor, round vents in the gable peaks.

The cottage is generally in good repair with no apparent issues.
