BELVEDERE CLUB 2019 ARCHITECTURAL INVENTORY

Site: 109

Year Built c. 1890

Architectural Style Shingle style

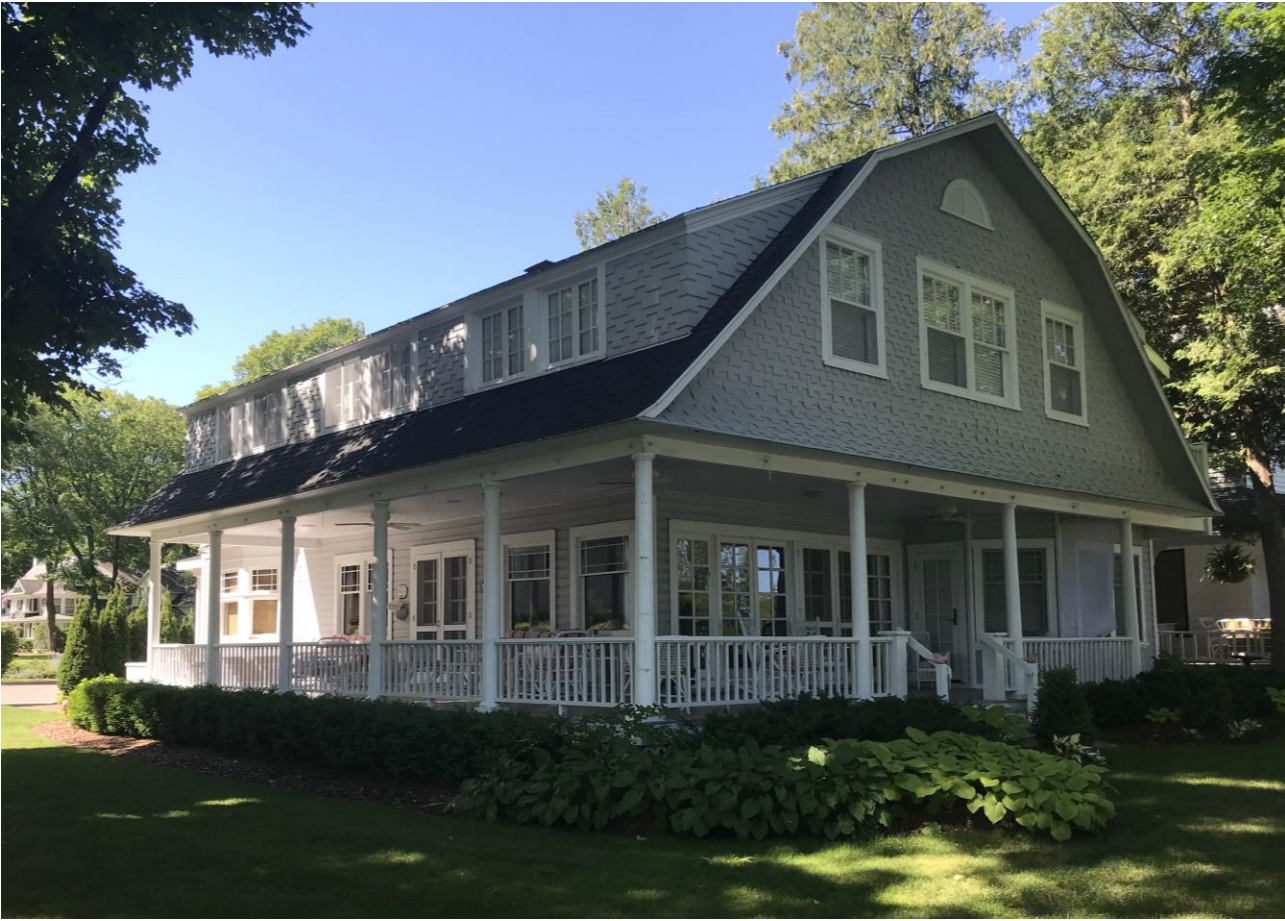
The gambrel roof with a shed roof dormer and windows in the gable ends creating a second floor that overhangs the first floor creating a wrap-around porch is typical of the Shingle style. The house originally had a small shed roof dormer, and less windows in the gable end, and different shingle siding. The first-floor footprint has been expanded but it appears the multi-sided bay window in the southeast corner is original.

- Gambrel roof creating a second story that overhangs the first floor creating a recessed wrap around porch with Doric columns.
- Multi-sided bay window in southeast corner.
- The upper sash of the first-floor windows replicate the historic pattern although the window sizes and location have been altered.

The cottage is generally in good repair with no apparent issues.
