## BELVEDERE CLUB 2019 ARCHITECTURAL INVENTORY

**Site:** 119

**Architectural Style** Prairie style

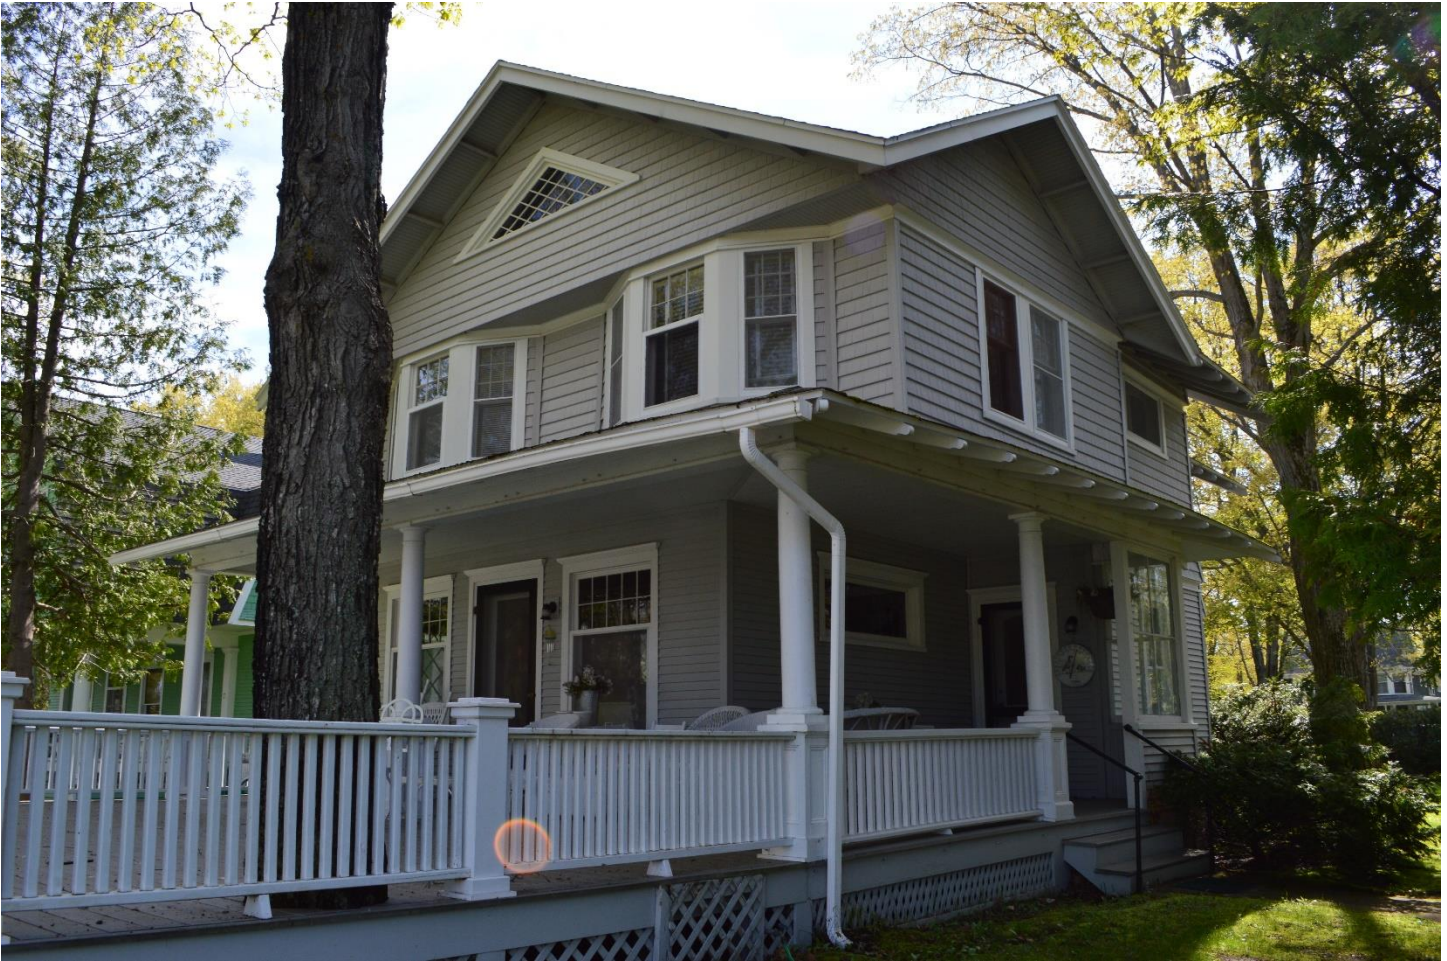
The two-and-a-half-story massing with a cross gable roof with deep overhangs, exposed rafter tails, the triangle window in the gable front, matching bay windows at the second floor and the deep wrap around porch with Doric columns supporting a shallow hip with exposed rafter tails are indicative of the Prairie style.

- Cross gable roof with deep overhangs, exposed rafter tails and triangle window in gable.
- Full width front porch with shallow hip roof with exposed rafter tails supported by Doric columns sitting on square bases with paneled sides.
- Two bay windows at second floor, rectangular window on north side at first floor.

The cottage is in good repair with no apparent issues.
