## BELVEDERE CLUB 2019 ARCHITECTURAL INVENTORY

**Site:** 121

**Architectural Style** Shingle style

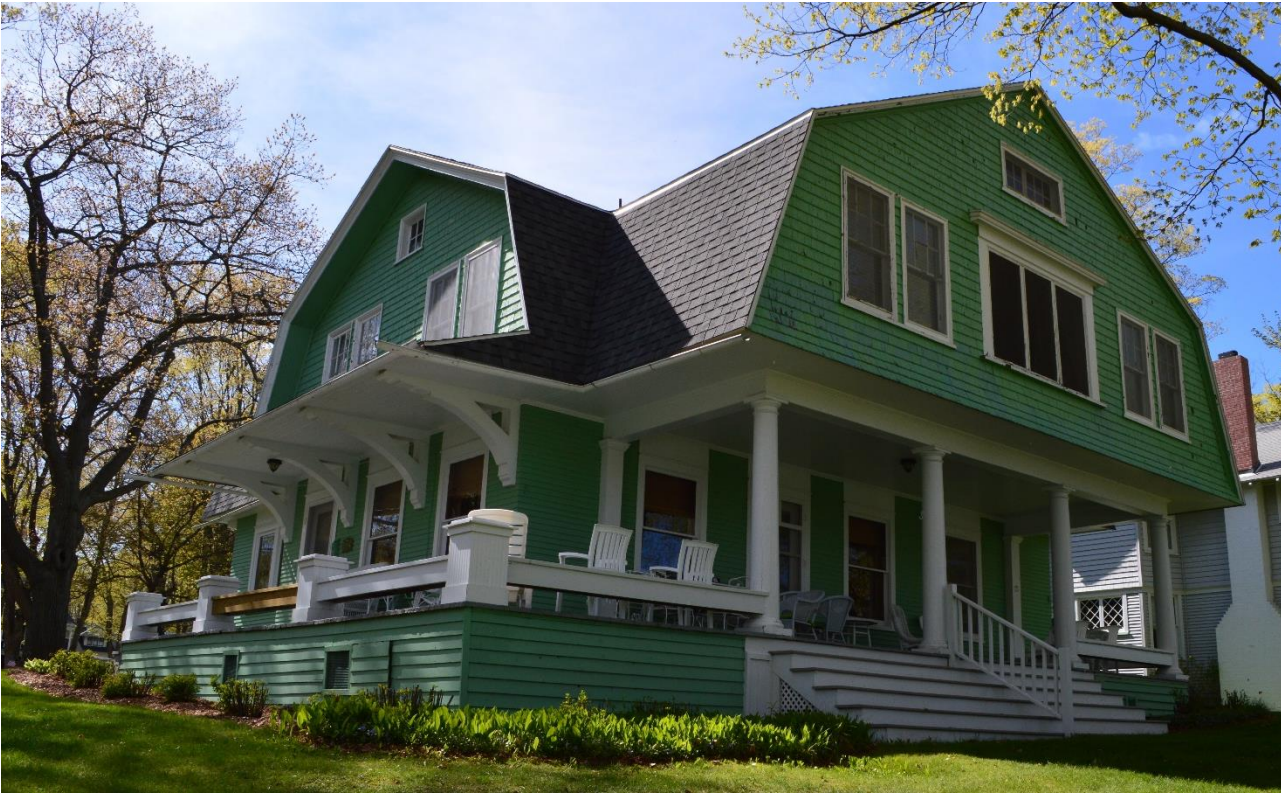
The two-and-a-half-story massing with a cross gambrel roof that overhangs the first floor creating a full width front porch supported by Doric columns and the shingle siding are all indicative of the Shingle style. The multi-pane windows at the top of the gables, as well as the second-floor windows with the multi-pane upper sash appear to be original.

- Cross gambrel roof over the second floor that overhangs the first floor creating a full width front porch with Doric columns.
- Shingle siding, multi-pane windows in the gable ends and at the second floor, the bay window on the first floor of the west elevation.

The cottage is in good repair.
