## BELVEDERE CLUB 2019 ARCHITECTURAL INVENTORY

**Site:** 403

**Architectural Style** Shingle

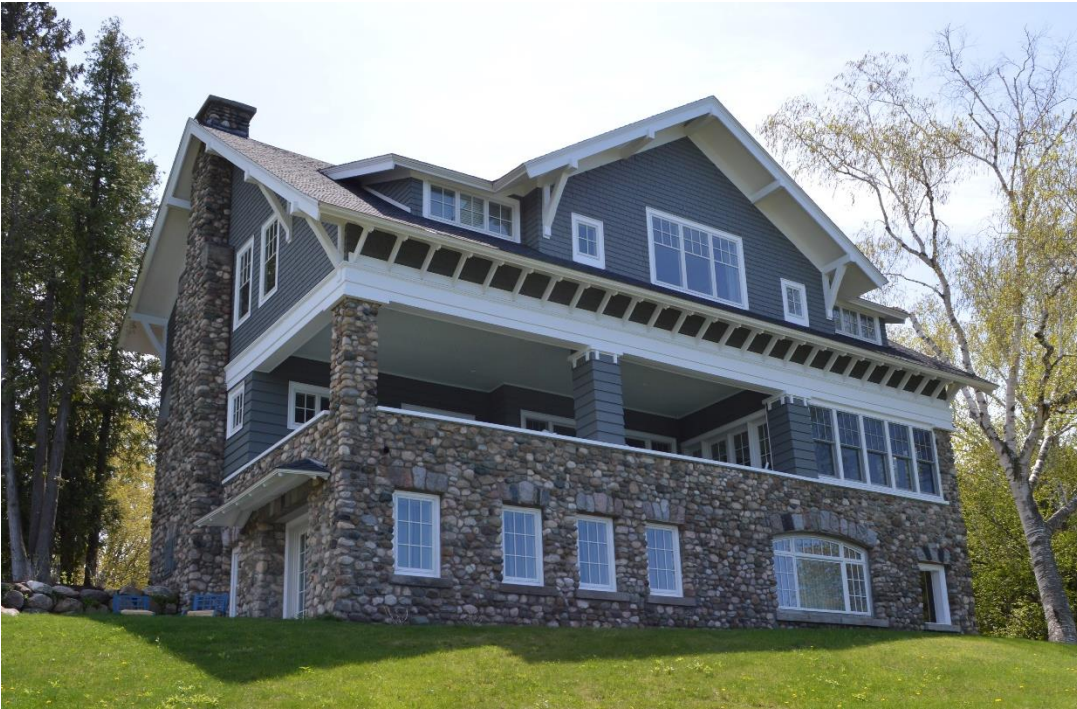
The steeply pitched side gable roof with deep overhangs supported by brackets creating a recessed front porch, along with the large gable front and shed roof dormers are all indicative of the Shingle style. The cobblestone basement level, porch post, and chimney, as well as the wide clapboard and shingle siding are also characteristic of the Shingle style. Although it appears that the windows have been replaced, they are in their original openings.

- Two-and-a-half story steeply pitched side gable roof with deep overhangs supported by brackets, gable front and shed roof dormers. Brackets where second floor overhangs first floor.
- Deep recessed north porch with cobblestone and clapboard clad pillars, the west portion of the porch has been enclosed. Pillars and trellis at south entrance door.
- Cobblestone basement level and chimney, wide clapboard at first floor, shingle siding at second floor and in dormers. Wide trim between first and second floor.
- Window opening sizes and locations.

The cottage appears to be in good repair with no apparent issues.

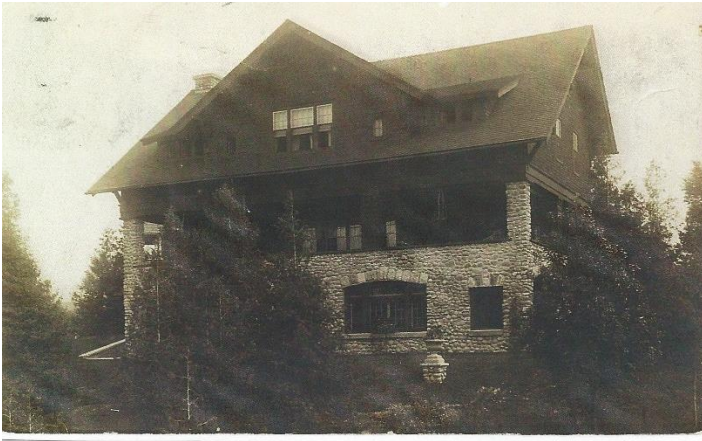
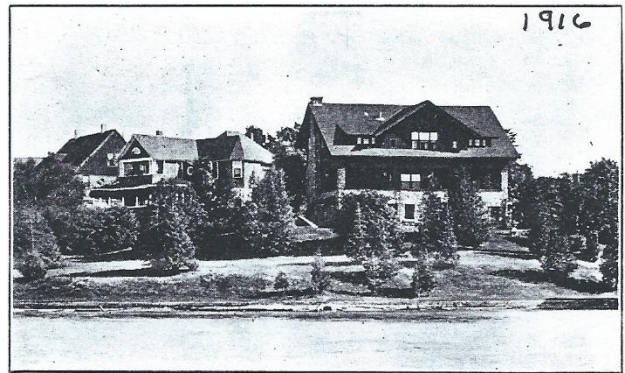
1910 and 1916

Cottages of  
B. T. Hosking, Chicago, Ill.      Sam'l Bailey, Jr., Cincinnati, Ohio
