BELVEDERE CLUB 2019 ARCHITECTURAL INVENTORY

Site: 502 **Historic Name** N/A
Year Built c. 1890
Architectural Style Colonial Revival

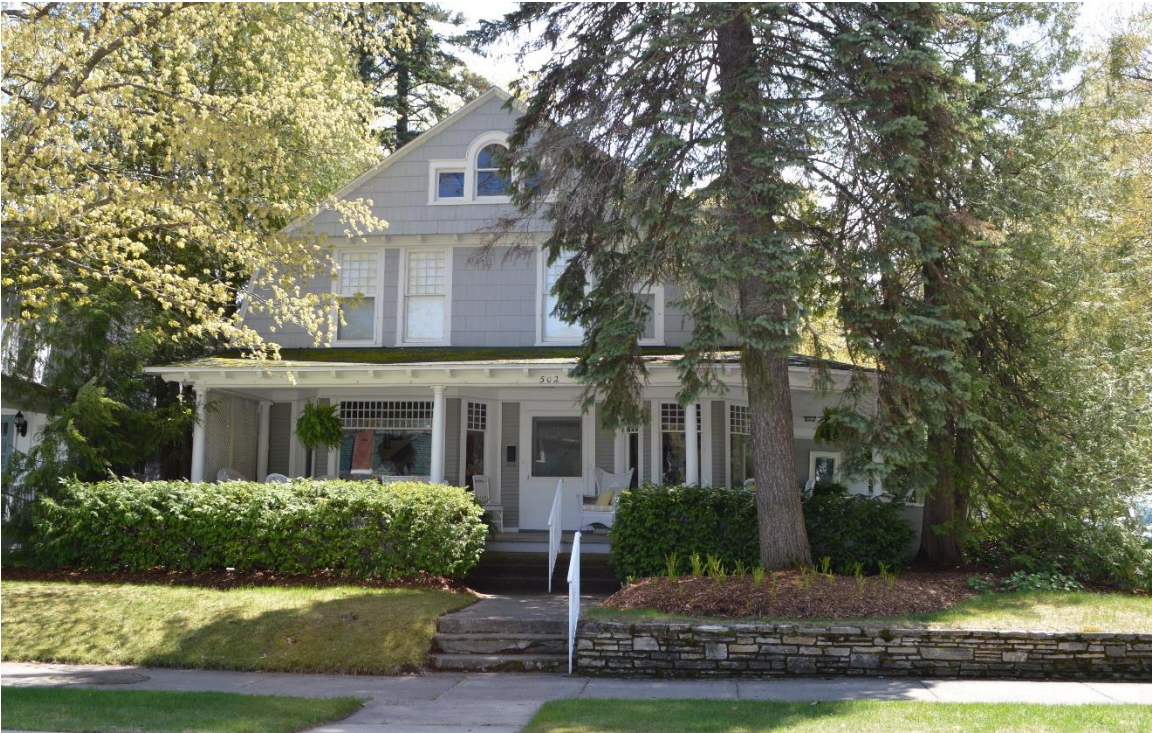
The large gambrel front roof with Palladian window in the center, brackets across the bottom of the gable, and wrap around front porch with curved edge, and Doric columns supporting the shallow hip roof with brackets along the eave are characteristic of the Colonial Revival style. The shingle siding at the second floor, narrow clapboarding siding at the first floor, second floor windows with multiple panes in the upper sash, and the first-floor windows with a larger bottom sash and upper sash with multiple panes are all typical for the style.

- Large gambrel front roof with Palladian window in center and brackets along bottom of the gable. West side hip roof dormer and gable front dormer with center brackets at the bottom of the gable. Rear gable front with brackets across the bottom of the gable.
- Wrap around front porch with curved corner, central stair, shingle sided knee walls, Doric columns, shallow hip roof with brackets at eaves.
- Bay window at first floor, windows with larger bottom sash and smaller multi-pane upper sash. Second floor windows with multi-panes in upper sash.
- Narrow clapboard siding at first floor, shingle siding at second floor and in dormers.

The cottage appears to be in good repair with no apparent issues although the large shrubbery next to house could cause future moisture problems. It retains most of its original appearance.

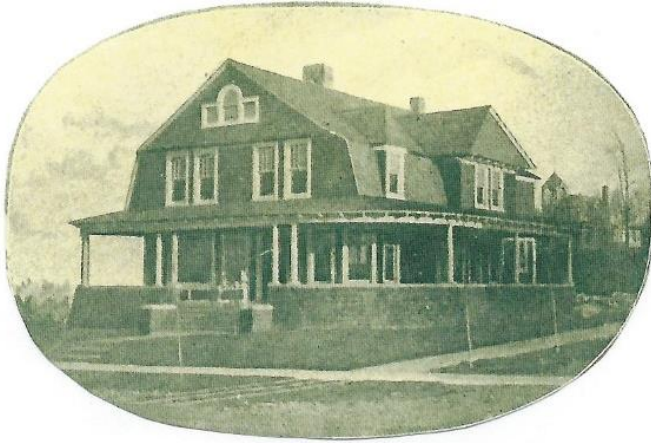
1907
R. P. Foley
